Photos of Architectural Features:

These pictures are presented to illustrate features mentioned in the HSR and to offer a glimpse of normally inaccessible parts of the house. The unit "B" cellar is full of duct work and wiring and is totally unlit.

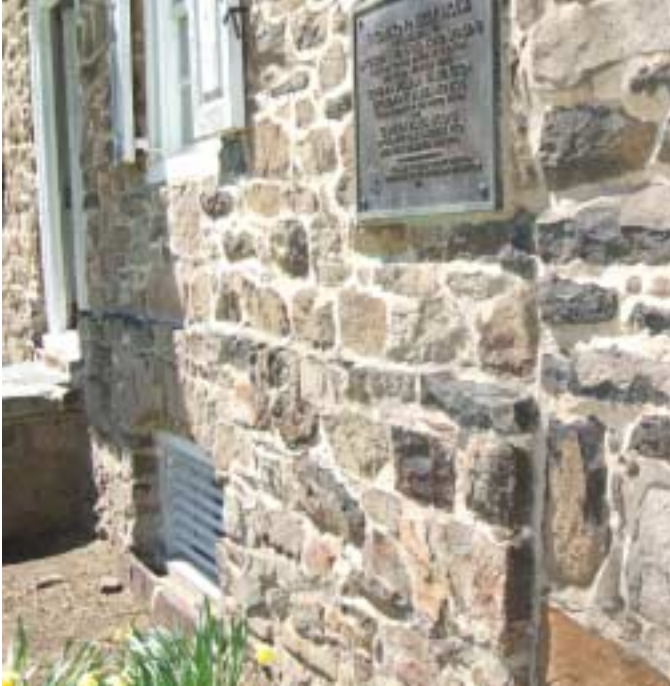
South exterior of unit "A". water table protrudes horizontally midway between cellar and 1st floor windows. It is noticeable in jagged shadow and shadowed edge at "A" – "B" vertical mortar seam

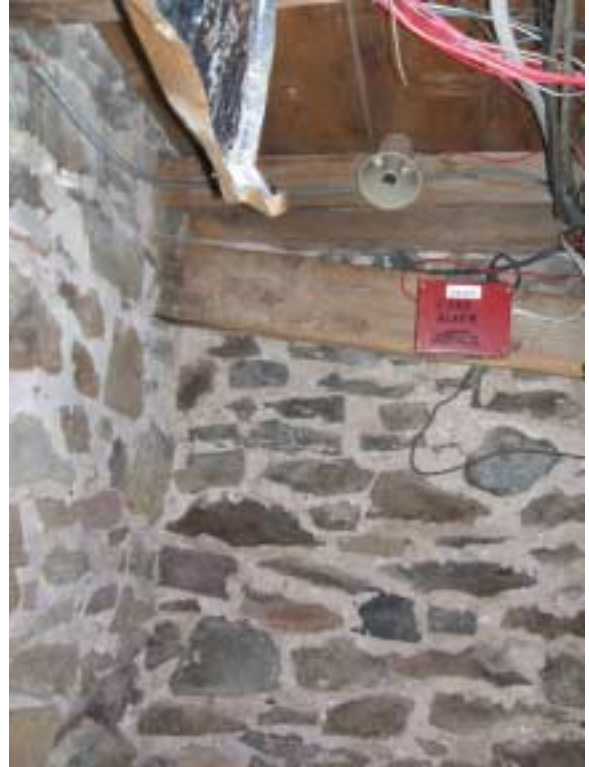
Current floor joist above old, sagging floor joist along east end of "B0" cellar. North end of old joist embedded in "B0" fireplace mound.

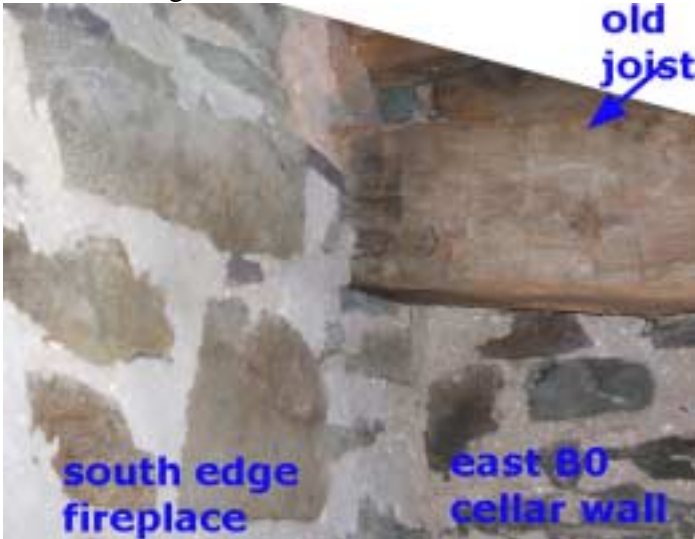
Close-up of old floor joist along east wall of "B0" embedded in south end of fireplace mass. Current floor joist directly above it.

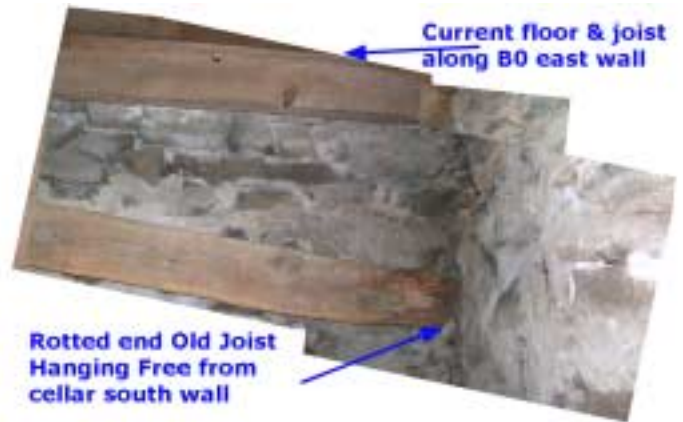
Close-up of rotted south end of old floor joist now disconnected from south "B0" cellar foundation and dangling free.

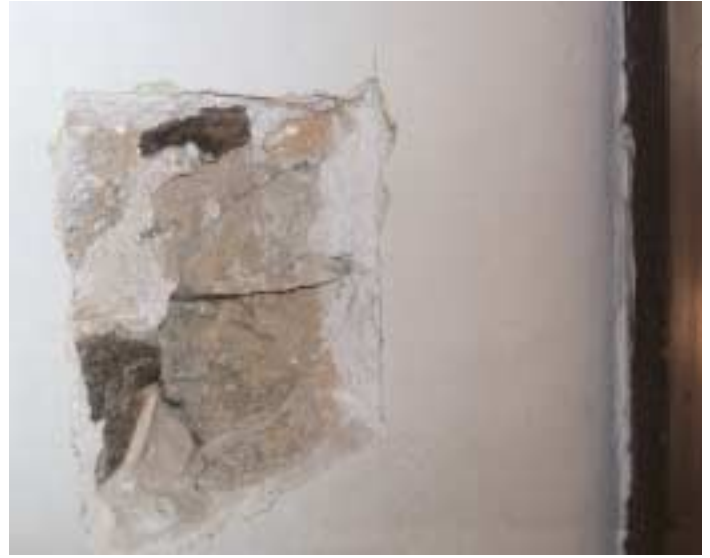
Removal of plaster to take mortar sample M13 from south side of south jamb of unit "B1" fireplace reveals fireplace construction. Door from "B1" to "C1" visible to right.

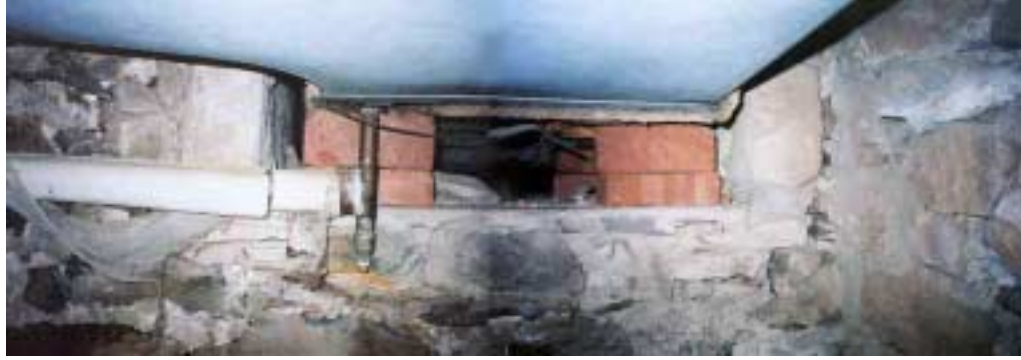
Opening in north wall "B0" to shed crawl space. HSR says wood sill [at base of opening] may date to an older structure. Brumbaugh says same for lintel (obscured by ductwork). West face Fireplace mass to right.

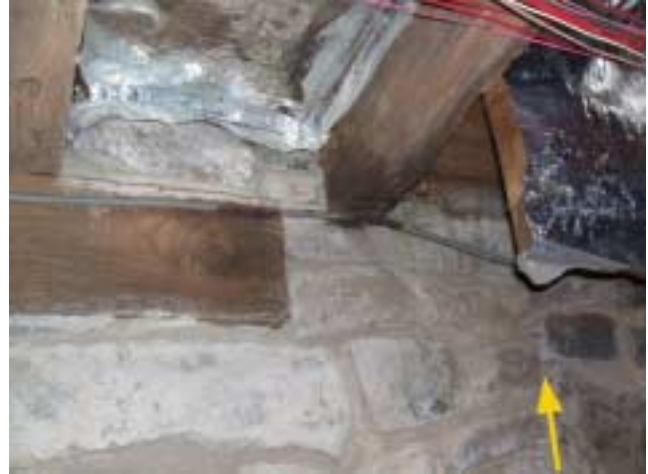
Summer beam embedded in west facing hearth extension (everything to left of yellow arrow) indicating floor was raised to new level when hearth extension added.

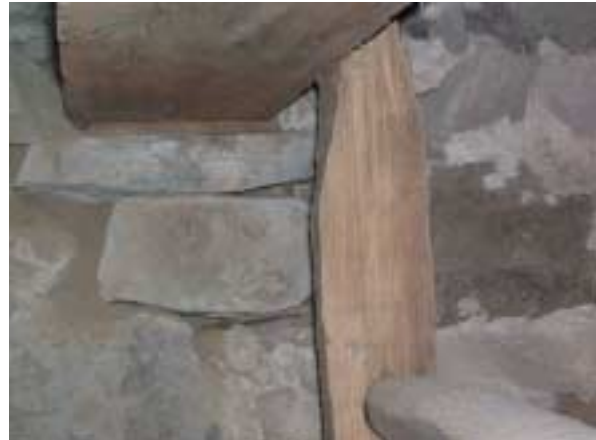
West end of summer beam rests on loosely piled rocks filling the pocket to bring the beam from its original position when unit "A" & this wall were built to its new position when hearth extension built..

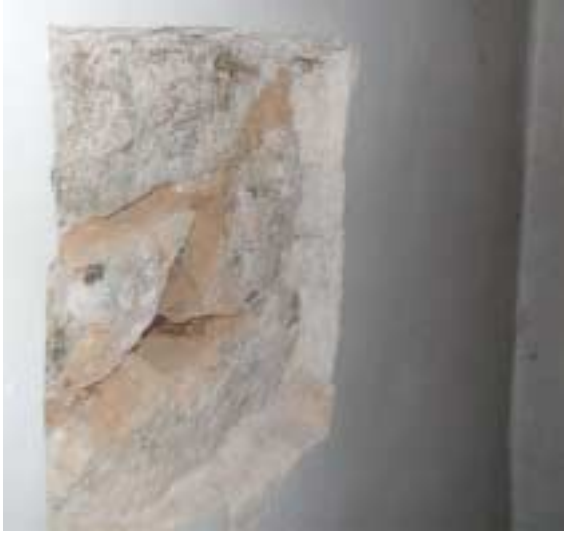
Exposed stone and mortar (M19) from north corner of west wall of room "B108", between cellar stairs and north window. This mortar contains horse hair, an older formulation than all the other samples.

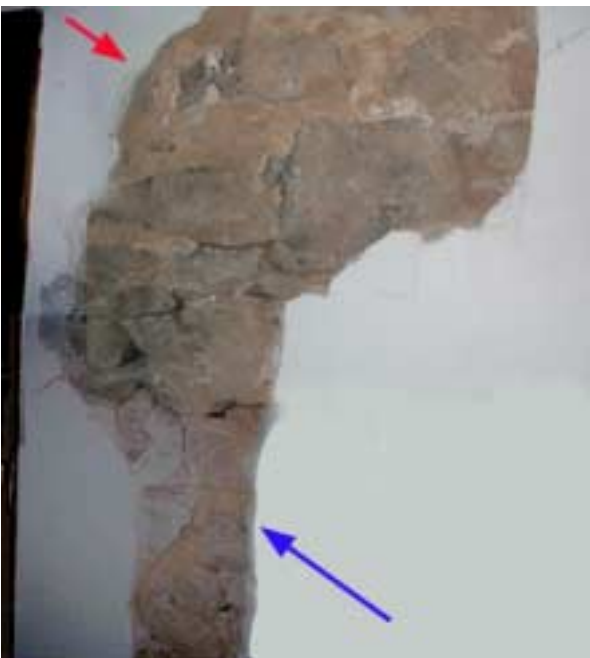
Red Arrow shows mortar with exterior finish. Blue arrow shows rough, unfinished interior garret mortar. Pencil diagonal line drawn on plaster shows the conjectured south roof slope, based on mortar.
