Photos of Architectural Features:

These pictures are presented to illustrate features mentioned in the HSR and to offer a glimpse of normally inaccessible parts of the house. The unit "B" cellar is full of duct work and wiring and is totally unlit.

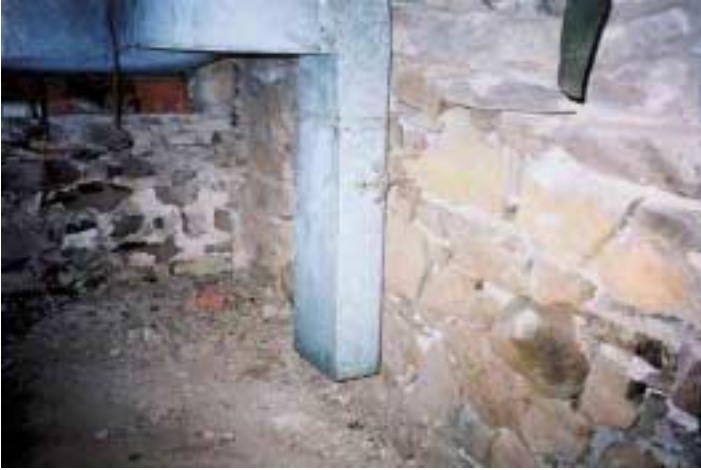
North wall & crawl-space entrance visible under duct work. Vertical duct abuts west face of "B0" fireplace mound hearth extension. Note variation in hearth extension finish.

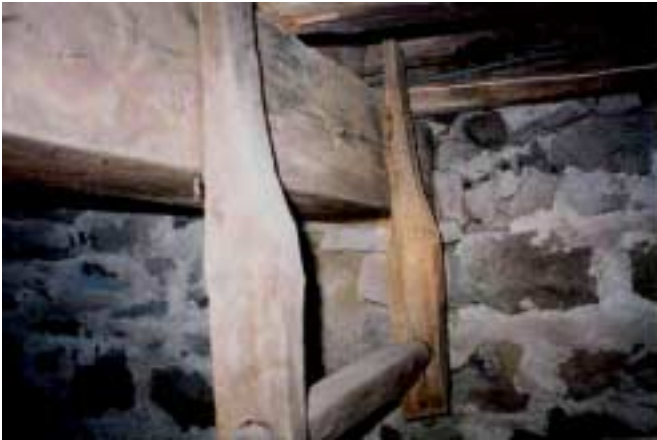
Storage rack hanging from central East-West summer beam under 1st floor joists in "B0" cellar. West end of beam rests in large pocket on west wall. (Other end is embedded in fireplace mass.)

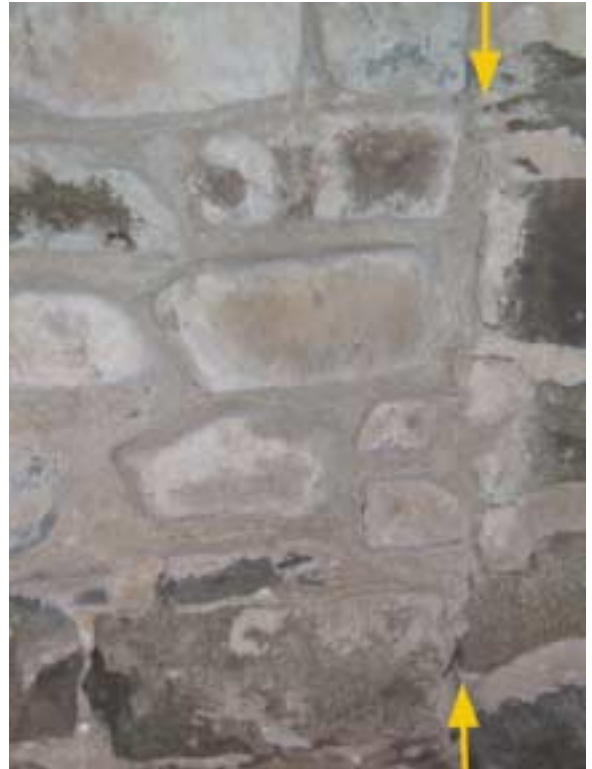
South edge of fireplace mass, showing vertical groove. Hearth extension is to the left.

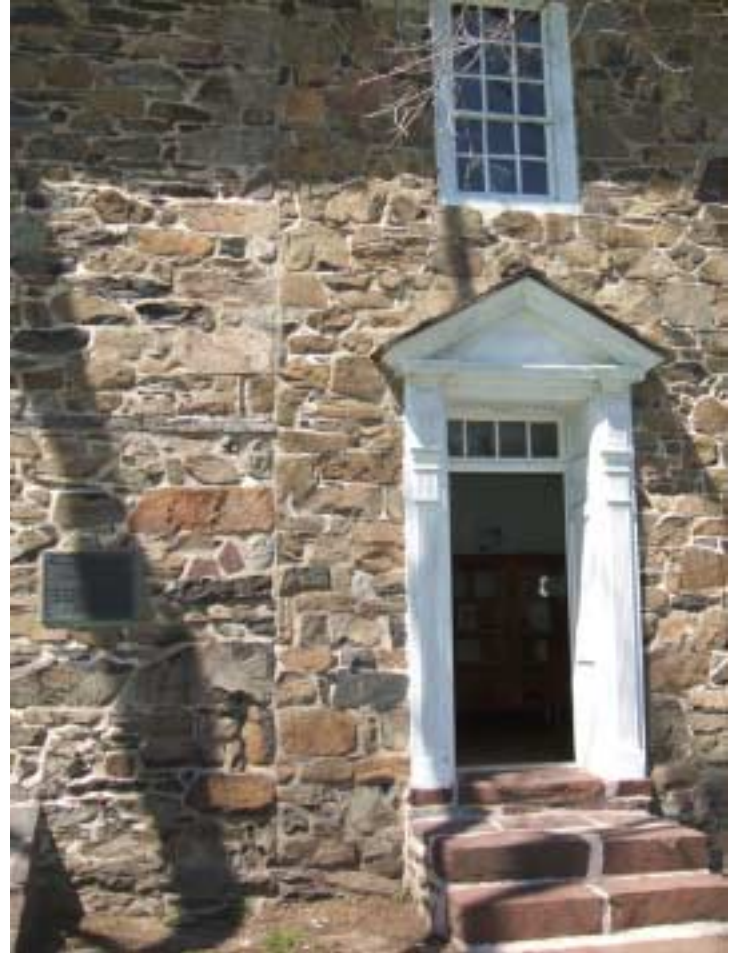
Vertical seam separating unit "B" from "C" on the right. Note large stone quoins forming SE but not SW corner of unit "B".

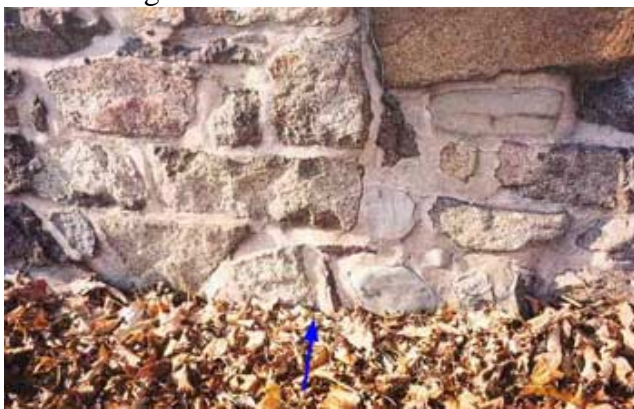
South wall Vertical seam jogs 4" to the east from unit "A", resulting in a ground-level notch.

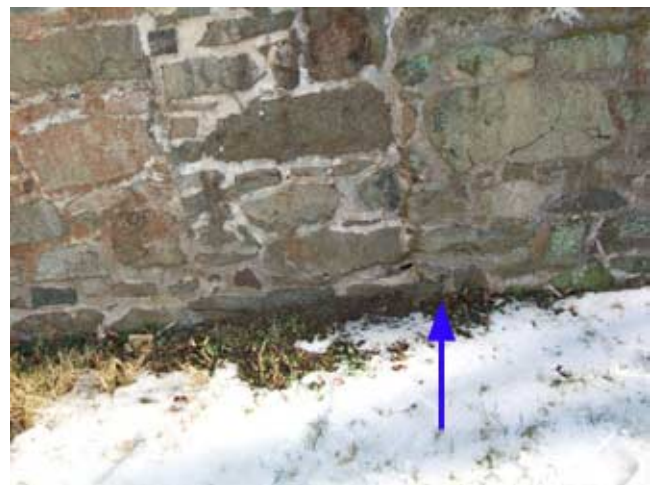
North wall Vertical seam jogs 4" to the east from unit "A", resulting in a ground-level notch

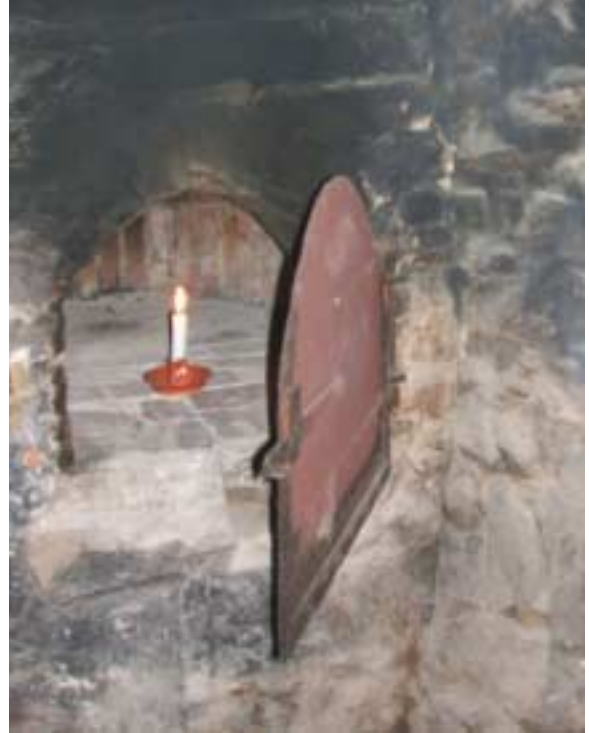
Beehive oven in north jamb of "B1" fireplace

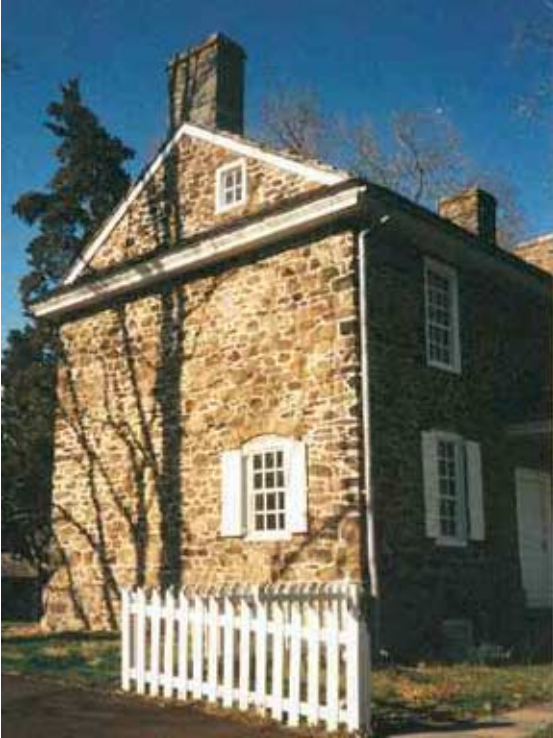
West end unit "A". Note Garret SW window, protruding ledge cornice. Once the east end of unit "A" looked like this, rotated 180° – it had a NE garret window. Note darker chimney stone.
